Capping Survey at the
New London Disposal Site
February 3, 1989

Disposal Area Monitoring System DAMOS

Contribution 71
January 1990

Report No.
SAIC-89/7554&C76

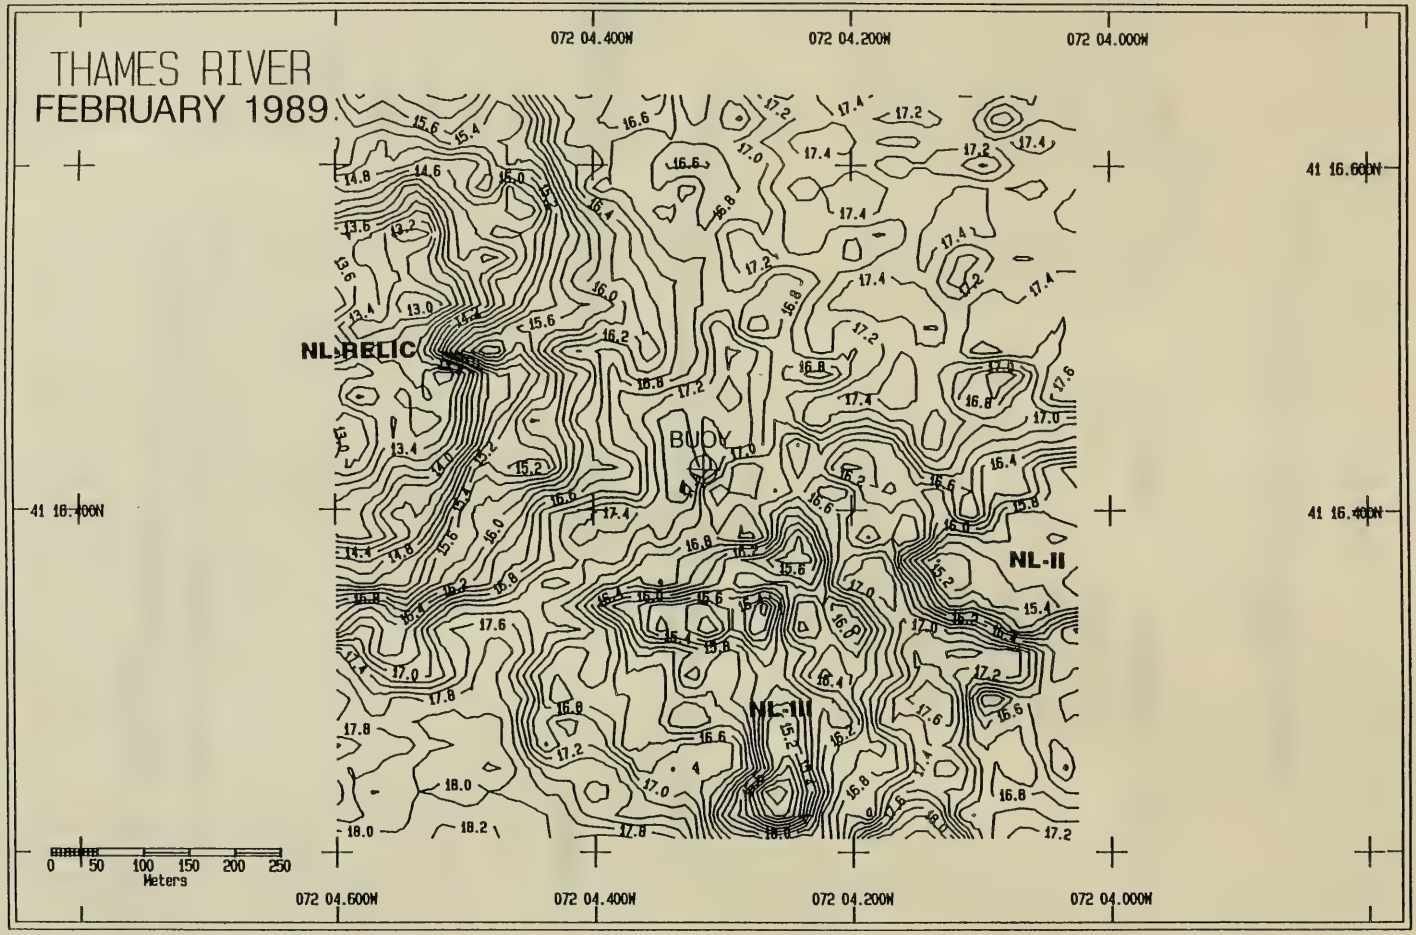
The contour plot from analysis of the 1989 bathymetric data revealed a highly variable topography of old disposal mounds resulting from dredged material disposed in previous years, as well as from cap material disposed at the buoy location (Figure 1). The clearly visible north-south contours running along the western border of the survey area delimited the eastern flanks of the old disposal mound NL-RELIC. The NL-III mound was seen along the southern border of the survey area. The western flanks of the NL-II mound were also shown on the eastern limits of the survey area. Changes in topography resulting from capping material deposition were indicated by comparison of this contour plot with the results of the October 1988 post-disposal survey (Figure 2).

Most of the capping material was evident in the area to the southeast of the buoy. At roughly 150 m south of the buoy, the cap layer showed a minimum depth of 14.8 m, in comparison to the 1988 minimum depth of 15.5 m at this location. Another topographic high of 15.6 m was detected 140 m southeast of the buoy in the 1989 contour plot, 0.6 m higher than the 16.2 m shown at this location in the 1988 contour plot. While this capping layer was relatively steep-sided in parts, it showed several isolated topographic highs. This reflected both the areal extent of the underlying disposal mound as well as a spatial variation in cap thickness ranging from 10 to 70 cm. It should be noted that in 1988 the western part of NL-II showed a minimum elevation of 15.5 m, whereas in 1989 the very western part of the mound showed a minimum elevation of 15.2 m. This indicated an extension of the cap layer to the edge of NL-II with a thickness of approximately 30 cm in this area.

Figure 1 Post-capping bathymetric contour plot of the Thames River Shipyard Disposal Location, February 1989. Contours at 0.2 m intervals.

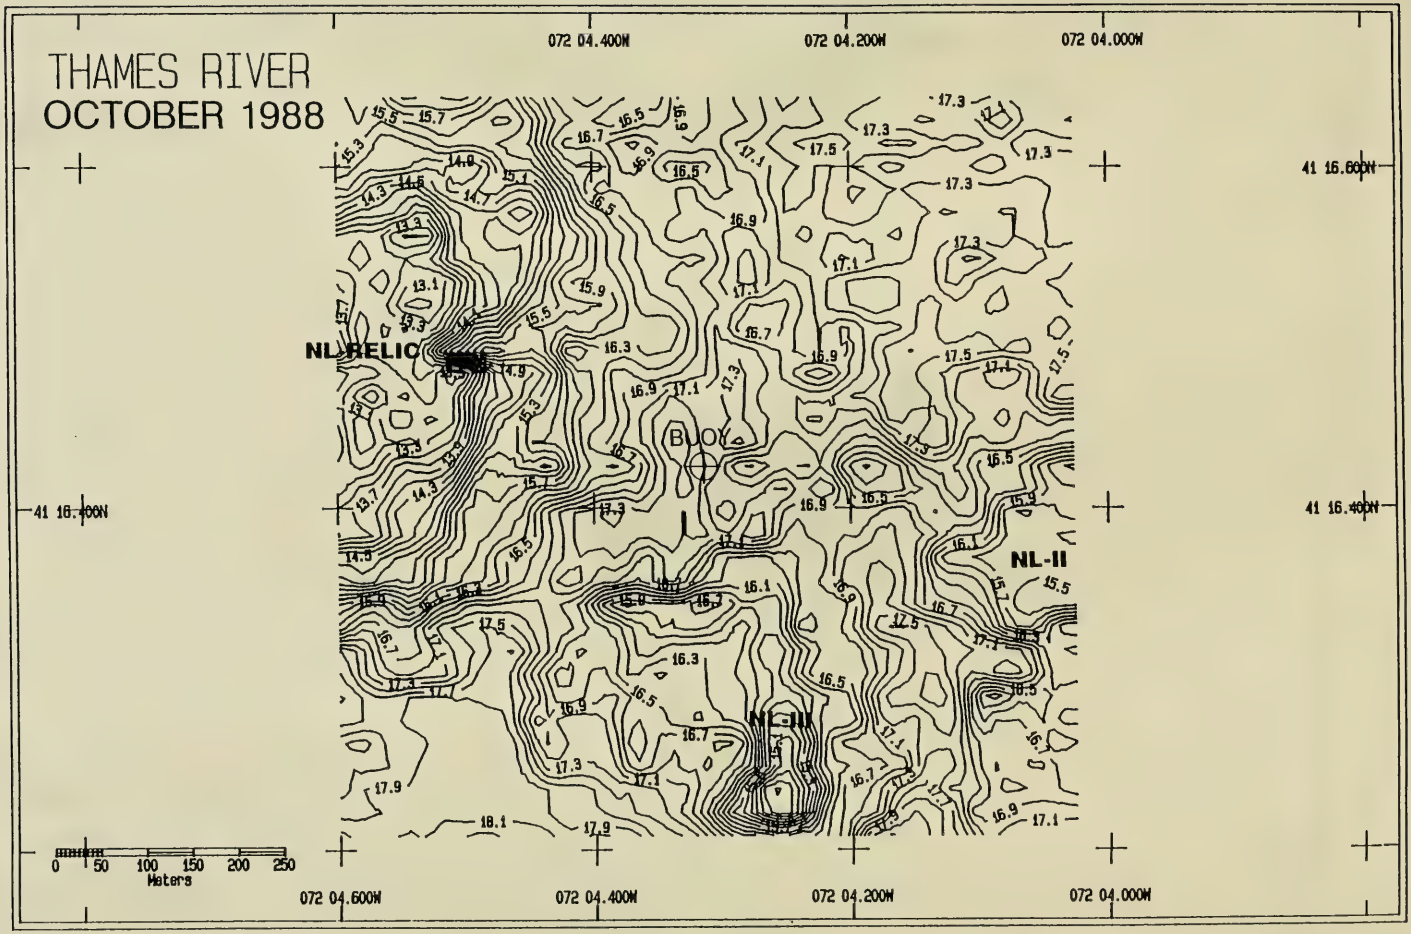
Figure 2 Post-disposal bathymetric contour plot of the Thames River Shipyard Disposal Location, October 1988. Contours at 0.2 m intervals.

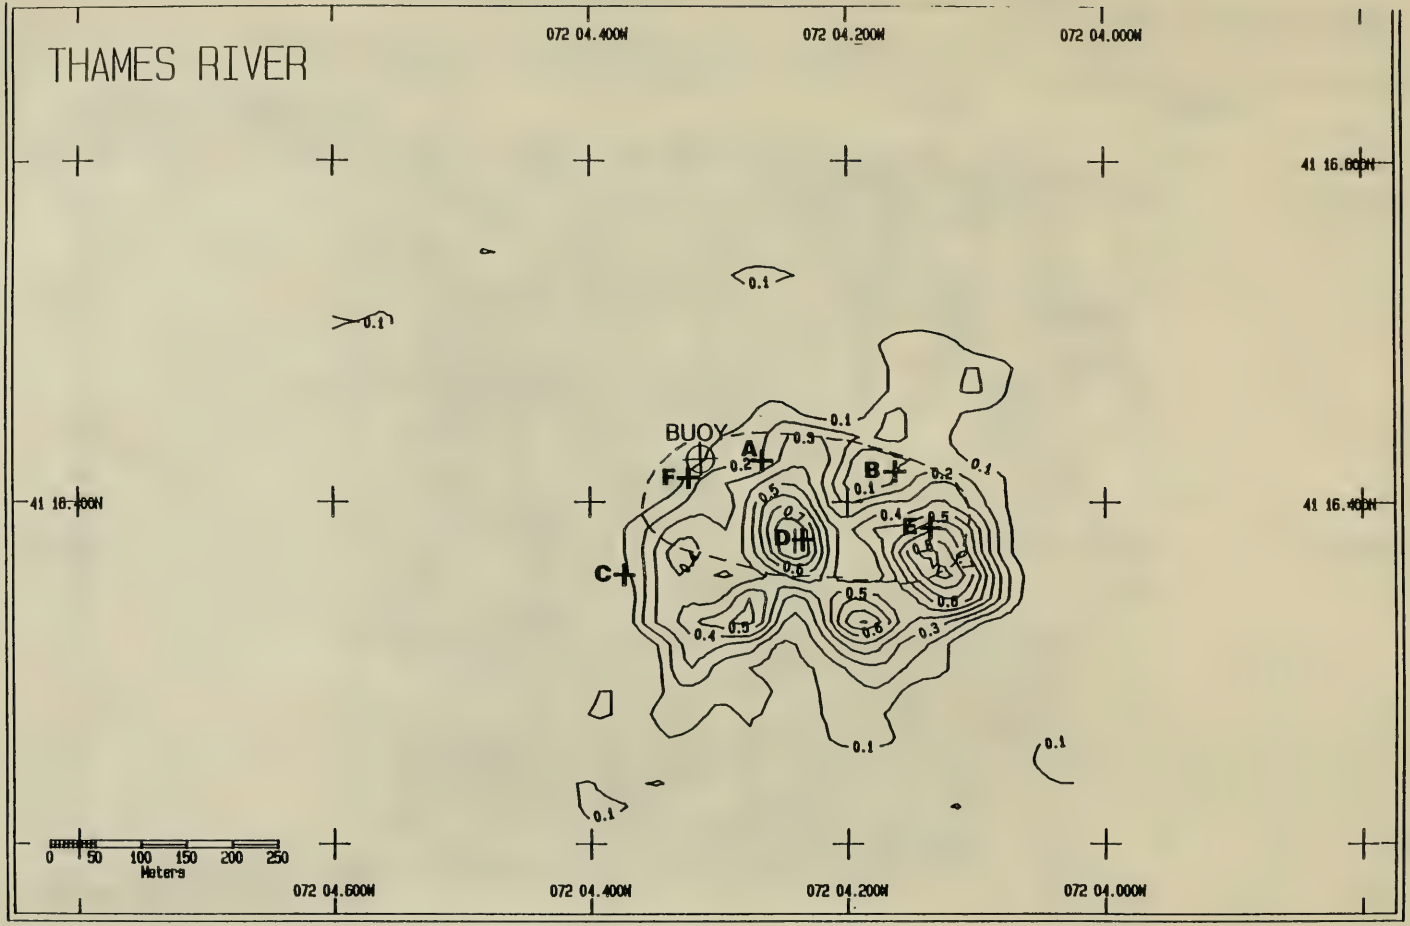
To determine cap thickness a depth difference plot was prepared by subtracting the depth matrix of the October 1988 bathymetric survey from that of the February 1989 survey (Figure 3). The cap material clearly showed a roughly circular and continuous distribution varying in thickness from 10 to 80 cm. This depth difference comparison resulted in a calculation of 28,270 m^3 of cap material detected at the site. According to scow log records an estimated 59,517 m^3 of cap material was deposited between October 1988 and January 1989 (Table 2).

Examination of the distribution of cap thickness in relation to the six recommended disposal points revealed that cap material was clearly deposited at points "D" and "E". These were the locations of the two thickest parts of the cap layer, having cap material accumulations of 80 cm (Figure 3). Cap thicknesses of 50 to 60 cm were also established to the southwest of these two disposal points. However, point "A" was intended to have received the most scow loads of cap material because of the contaminated dredged material thickness at this point (Table 1). The depth difference contour plot indicated only 20 cm of cap material here. At disposal points "B", "C", and "F" only 10 cm of cap material appeared to have been deposited (Figure 3).

The erratic topography of the cap layer generally reflects the spatial distribution of the recommended disposal points (Figure 3). However, detected cap thicknesses surrounding these locations suggests a consistent shift in cap material deposition to the southeast. The largest volumes of cap material were reportedly disposed of at points "A" and "B" (Table 2). However as already noted, the two thickest parts of the cap layer actually detected are located at points "D" and "E". These points are offset to the southeast of points "A" and "B". Similarly at point "F" little cap material was indicated in the depth difference contour (Figure 3), yet a localized cap layer of 40 cm was detected just south of this disposal point. Similar topographic highs in the cap material distribution were indicated south of disposal points "D" and "E" (Figure 3). This suggests that some offset was consistently

affecting the positioning accuracy of cap material deposition during the capping operation. Most likely this was due to a consistent Loran error, resulting in the cap layer effectively covering the majority of the contaminated dredged material with the exception of the northern and western borders of its distribution.

Figure 3 Depth difference contour plot of the Thames River Shipyard Disposal Location, showing the distribution of cap material, February 1989 - October 1988. The dashed contour line indicates the mapped distribution of contaminated dredged material as detected by the REMOTS survey of October 1988. Points "A" - "F" are the disposal point locations recommended in the Thames River Shipyard capping plan (SAIC, 1988).

It appears that additional capping material is required at certain locations along the northern and western borders of the disposal mound. It is recommended that additional material be deposited at locations "A", "B", "C", and "F" in order to cover the contaminated material with a sufficiently thick layer of clean material (between 50 to 100 cm). However, because of discrepancies between the recommended disposal point locations and the actual distribution of cap material detected, it is recommended that

greater navigational control be employed during disposal of this additional cap material. This could be achieved through either the use of better navigational systems (e.g., shore-based microwave), or the temporary deployment of a disposal buoy at each of the locations requiring additional capping material.

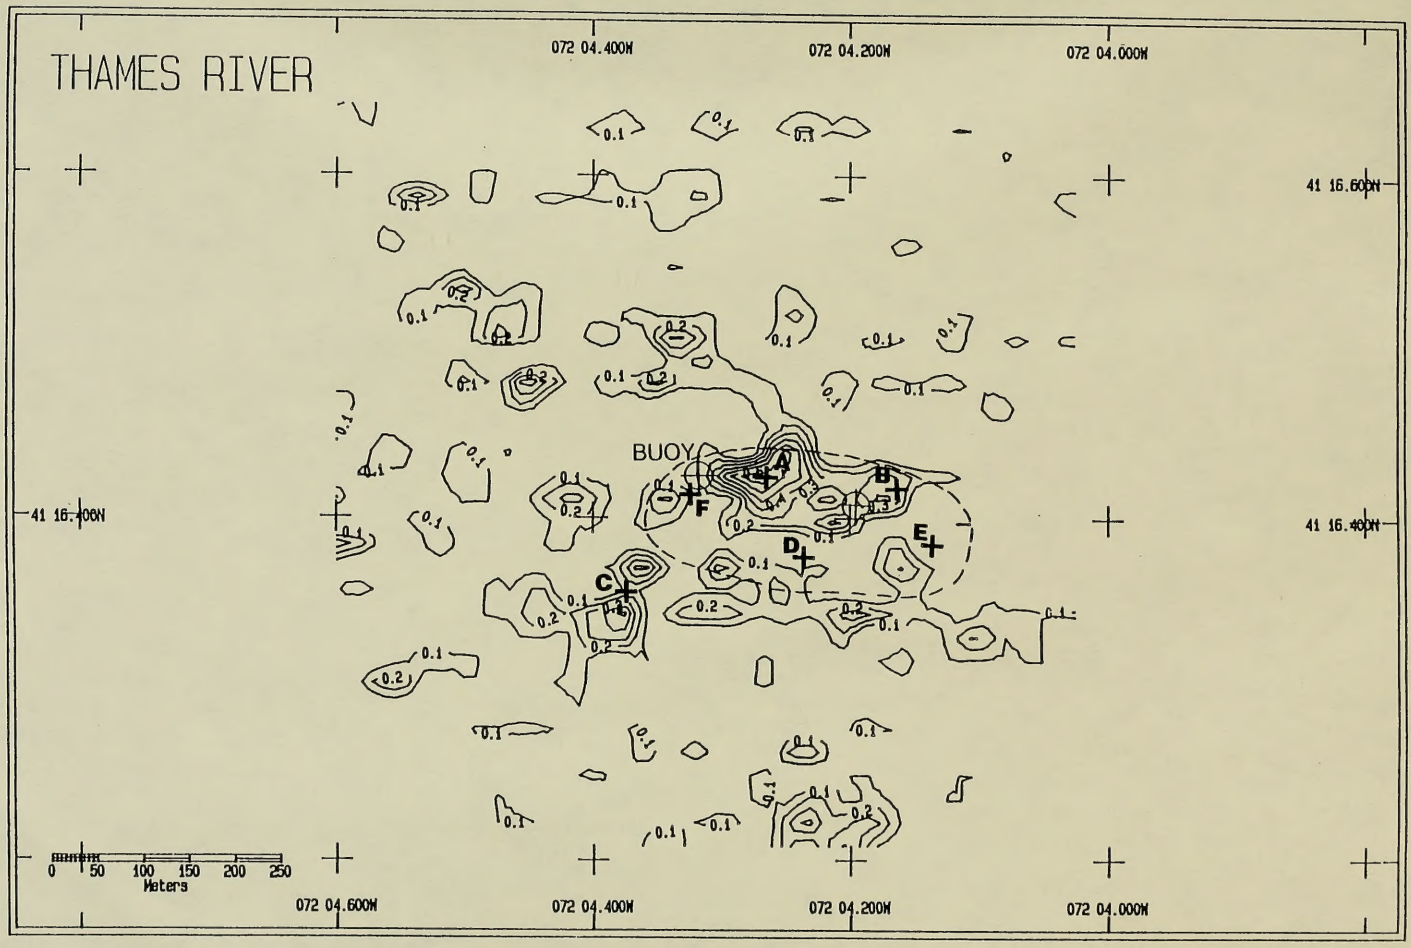
Depth difference calculations from the pre- and post-disposal bathymetric surveys of contaminated material revealed the distribution of material requiring capping (Figure 4). The mapped distribution of dredged material indicated from the REMOTS® survey of this area conducted in October 1988 confirmed this distribution detected by bathymetric techniques, and extended it roughly 50 m to the south, east and west (SAIC, 1988). Superimposing this distribution of dredged material as detected by the REMOTS® survey of October 1988 over the cap distribution detected in 1989 again confirmed that most of the contaminated material did receive some cap material (dashed line, Figure 3). However, at disposal point "A", 70 cm of contaminated material apparently received only 20 to 30 cm of cap material (Figures 3 & 4). In addition, at disposal point "F" 10 to 20 cm of contaminated dredged material was apparently capped by only 10 cm of clean material based on the 1989 bathymetric depth difference plot (Figure 3).

The depth difference plot from the pre- and post-disposal bathymetric surveys of contaminated material indicated a small deposit located roughly 150 m southwest of the buoy (near point "C", Figure 4). Although this material fell outside the mapped distribution of dredged material verified by the 1988 REMOTS® survey, it was recommended that this deposit be capped in addition to the main disposal mound because of the substantial amount of material detected here in the depth difference comparison (SAIC, 1988). This location should have been covered by scow loads of cap material deposited at point "C". However, the 1989-1988 depth difference plot indicated little or no cap material at this location. It should be noted that bathymetric surveys are limited in their ability to detect thin layers of sediment typical of disposal mound flank deposits. Thus, it is likely that the actual borders of the cap layer extend further than indicated in the bathymetric depth difference contour plot, covering locations such as disposal point "C". However it is unlikely that such flank layers would be thicker than the minimum change in depth detectable by bathymetric techniques (10 cm).

Figure 4 Depth difference contour plot of the Thames River Shipyard Disposal Location, showing the distribution of contaminated dredged material, October - August 1988. The dashed contour line indicates the mapped distribution of contaminated dredged material as detected by the REMOTS survey of October 1988. Points "A" - "F" are the disposal point locations recommended in the Thames River Shipyard capping plan (SAIC, 1988).
